# Causes of Damage of Rural Road in Coastal Areas of Bangladesh

Md. Jahangir Alam<sup>1</sup>, Mohammed Emdadul Karim<sup>2</sup>, and Md. Shamsul Hoque<sup>1</sup>

**ABSTRACT:** Developing countries spend a lot of budget each year for elevating, widening or repairing the existing coastal rural roads. These rural roads are constructed for a design life of 10 years. But these low volume roads loose serviceability within two or three years. To find out the reasons of less sustainability, different rural road sites in coastal region were visited by the authors and sandy soil (used for Improved Subgrade) and clayey soil (borrow pit soil used for side slope and shoulder) were collected from 28 sites. Grain size analysis, liquid limit and plastic limit of collected samples were determined. Fineness Modulus (FM) of sandy soils ranged from 0.00 to 0.50 and the most borrow pit soils are lean clay. Dynamic Cone Penetration (DCP) tests were conducted on pavement and shoulder. The test results were analyzed and compared with the Local Government Engineering Department (LGED) recommended DCP values for rural road by employing the AfCAP LVR-DCP software. It is found that the DCP values of base

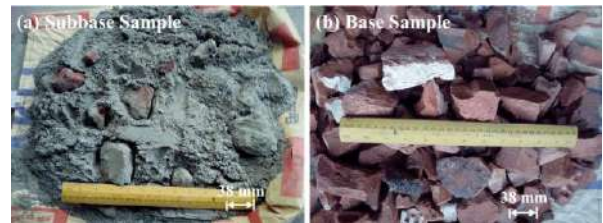
Recommended size of the burned clay brick chips for subbase and base is 38mm down well graded brick chips (Road Design Standards of LGED, 2005). In many cases, it was found that 70% (by weight) of the total brick chips are larger than 38mm (see Figure 5). As per LGED specification, the ratio of the brick chips and sand should be 1:1 in subbase. In such a mixture, the brick chips become isolated and suspended in the fine sand matrix where property of sand dominates in stress-strain behaviour of the mixture. This ratio need to be revised based on experimental study using different mix ratios. In the field, more than 65% fine sand was found in sand-brick chips mixture. In the base, used brick chips are made from 2<sup>nd</sup> class clay bricks which are not properly burned in many cases. This type of brick chips are easily break-down during vehicle movement resulting rutting at wheel position of the road. These sub-base and base are responsible for rural roads with rutting, a lot of pot holes and damage.

Figure 5 (a) Sub-base and (b) Base samples collected from Kaliganj, Satkhira

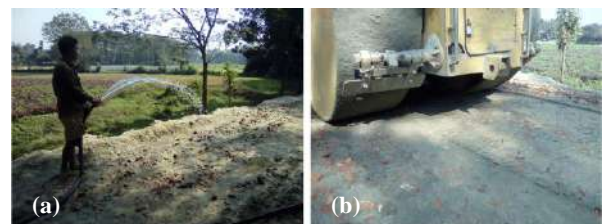
One site was visited while the subbase construction was ongoing. There, brick chips and fine sand are mixed at a ratio of 1:1 to use as sub-base. After mixing, the samples were watered by the labours. The labours did not have any moisture meter to measure the immediate moisture content of the sample while rolling. They do not have any training or knowledge about optimum moisture content. They just water until the sample gets wet (see Figure 6(a)). Thereafter, the rolling is done (Figure 6(b)). It is possible to get better CBR value by maintaining the moisture content and proper compaction. So, better performance of road can be achieved by supplying the portable moisture meter and giving training to the workers, how to measure the moisture content and do better compaction.

Figure 6 (a) Mixed brick chips and sand (1:1) in Sub-base and watering before rolling and (b) after rolling.

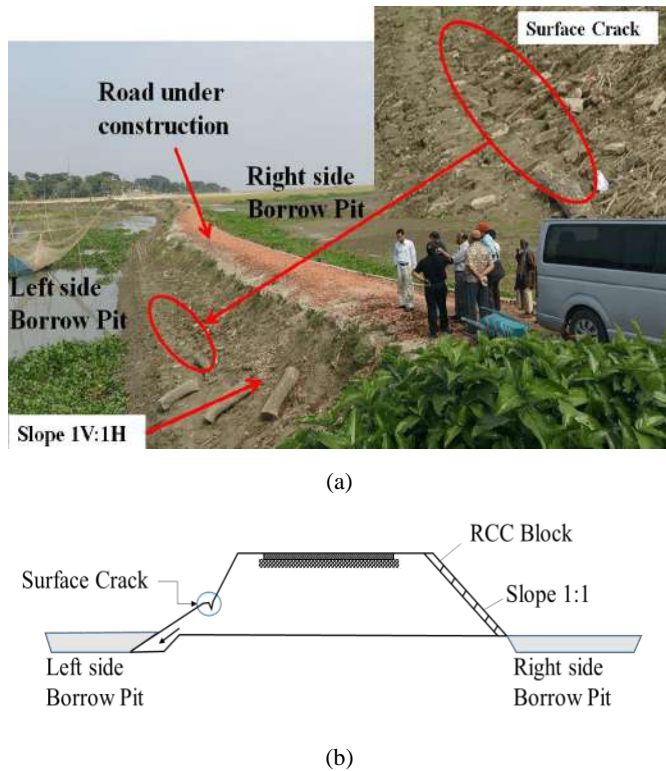
In most of the sites, side slopes of roads were found steeper (1V:1H) than the design value. Side slope of embankment mentioned in the Road Design Standards of LGED (2005) is 1V:1.5H for clayey soil, 1:2 clayey sand and 1:3 for sand or silty sand. Figure 7(a) shows a road at Bilaspur, Kaziarchar, Shariatpur. As the slope is steeper and the height of the road is more than 3.66 m, a surface crack was observed on the slope. To make it clear a real figure and schematic diagram is shown in Figure 7(b). Due to the steeper side slope and poor compaction, the crack also appeared on the shoulder of the road at Uttarpara, Uzirpara, Barisal (see Figure 8). Here, the Reinforced Cement Concrete posts were tilted. To make the steeper slope soil improvement need to be done or some protection system need to be followed. In some instances, farmers cut the embankment at toe making vertical cliff. This is another reason of steep slope of road embankment.

Figure 7 Failure line is observed in a road of Bilashpur, Kaziarchar, Shariatpur: (a) Photograph, (b) schematic diagram.

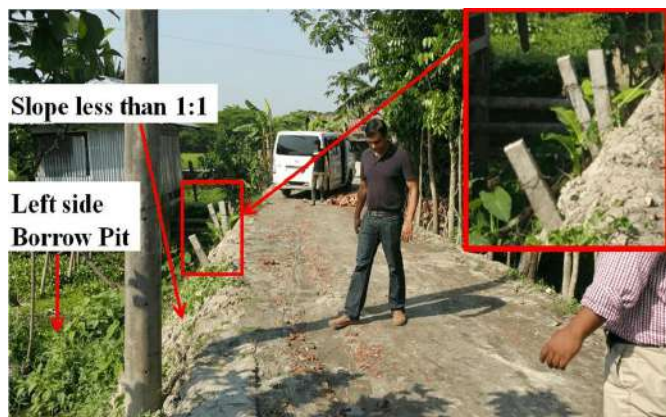
Figure 8 Steep side slope of rural roads in the study area (Location: Uttarpara, Uzirpar, Barishal).

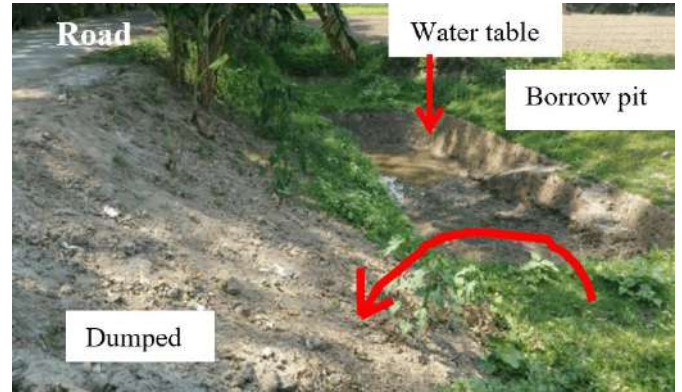
Borrow pit locations were found at very near to the road in most of the cases. Borrow pit location should be at least 3 m or 1.5 times of road height (which one is bigger) away from toe line (Road Design Standards of LGED, 2005). But in Figure 9, it is observed that the location of the borrow pit is at the toe of embankment. This is another reason of surface crack shown in Figure 9. This kind of mistake is very common in the rural areas.

Figure 9 Borrow pit was at the toe of the road. (Location: Babubazar, Barishal).

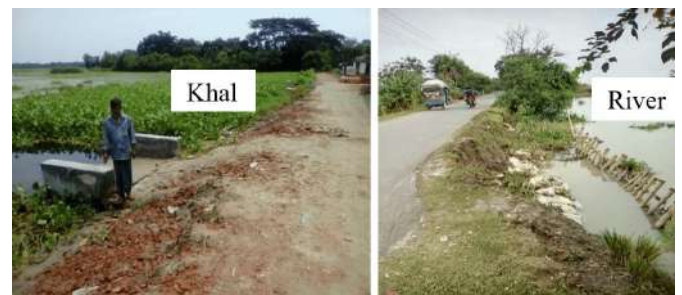
Some rural roads run along the bank of river or khal (Figure 10). This kind of road needs slope protection works for sustainable road construction. Sometimes, slope protection work is done using CC block revetment as shown in Figure 12. This is a typical design which is followed everywhere without any slope stability analysis. That is why sometimes slope failures are observed as shown in Figure 10(b) and Figure 12. Limited fund of rural road construction is a reason of not doing any proper slope protection design. If the slope protection is designed properly, construction cost of project will be more than the estimated budget.

Figure 10 Road along (a) khal and (b) river.

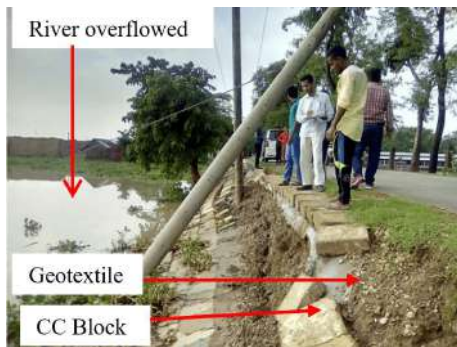
Figure 12 Embankment slope failed.

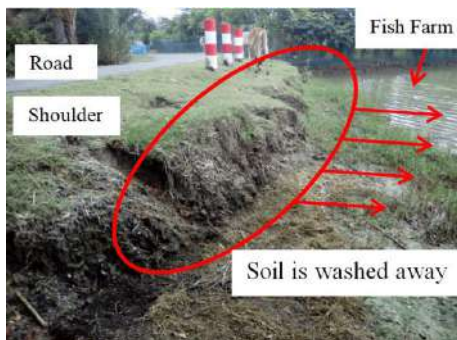
Figure 13 Side slope of rural road washed away by wave action.

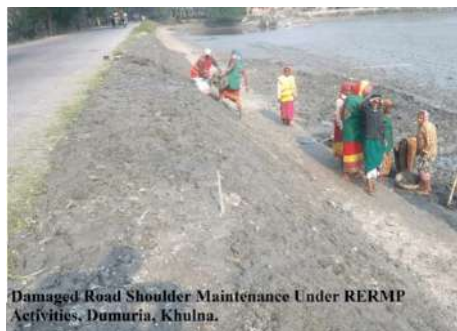
Crab, lobster and other fish farming in the coastal area are very common in Bangladesh. Nowadays, the farmers in the Bangladesh are converting their paddy lands to shallow water ponds (local name: Gher) to get more profit by doing fish farming. So, in the both side of the road the water exists throughout the year. Due to shallow water, wind generated waves erode side slopes (see Figure 13). Sometime, both sides of the road collapsed. Soil is not available for widening and elevating road. Dewatering of fish farm is done for road construction and the muds of the fish farms are used for road widening without. Figure 14 shows damaged slope repairing using mud of dewatered fish farm. The soil is too wet to compact.

Figure 14 Mud is dumped for repairing side slopes and shoulder (source: LGED website).

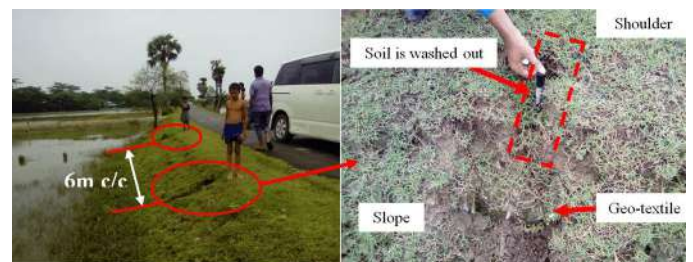
Authors observed a subsurface drainage path is installed in some recently completed rural roads. In the both sides of subgrade layer aggregate and sand wrapped with geo-textile are installed. The cross section of this modified road is shown in Figure 15 (a). This wrapped aggregate and sand mixture would work as a drain line through subgrade of the road. Here, the water inlet and outlet are placed in a zigzag pattern that is illustrated in Figure 15(b). Subgrade drain is 450 mm wide and 300 mm thick (Figure 15(a)). The center to center distance of subgrade drain is 6 m. However, in the rainy season it was found that the soils above the subgrade drains were washed away (the dashed oval marked portions in Figure 16). In Figure 16 (a) two photographs are exhibited where this type of erosion observed.

Figure 16 Effect of sub-surface drain.

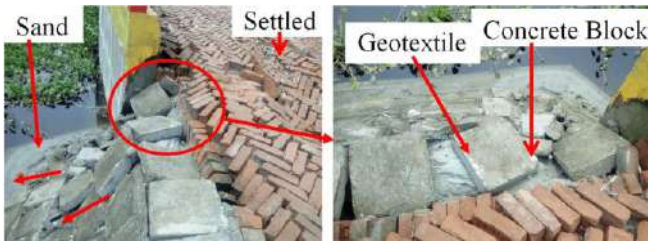
Approach road on the two side of bridge need extra attention in construction methodology and design. Removal of mud from the base of approach road and proper compaction of fill is necessary. More importantly, alternative design is needed to avoid differential settlement between abutment and approach road. In Figure 17, some photographs are added to show the settlement of approach road. Geotextile and CC blocks were used for slope protection at approach embankment. Consolidation settlement of underlying soft soil, lack of compaction of approach embankment and inadequate wing wall

are the major reasons of approach road damages. Sand compaction pile or PVD with preloading may be adopted to improve soft soil.

Figure 17 Damages of an approach road of a bridge.

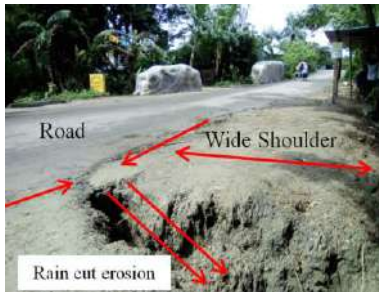
Lean clay or silt from nearby borrow pits are dumped at shoulder and side slopes. As the water table is high in the coastal region, so the collected borrow pit soils are highly moist and difficult to compact. In most of the cases, side slopes and shoulders are washed away during torrential rain in the next monsoon after construction (Figure 18) or the rain water makes her own path by eroding the shoulder.

Figure 18 Rain cut erosion in shoulder without vegetation

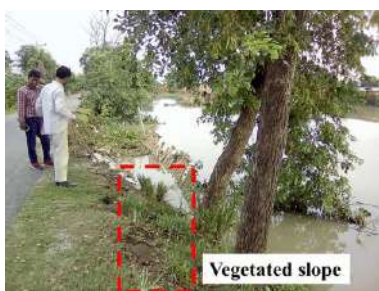
Vegetation is eco-friendly and has a very beneficial effect on the side slope protection. In many cases, it helps to make a sustainable slope. But, due to lack of maintenance and inadequate sunlight, it does not grow properly to protect the slope (Figure 19). Sometimes, deep seated slope circle failure occur which cannot be protected by vegetation only. At the side slopes, trees are planted to protect slopes. Sometimes, trees are uprooted (Figure 19) during storm and shoulder and road are damaged. This uprooted trees should be removed immediately and road should be repaired.

Figure 19 Slope failed in a vegetated slope.

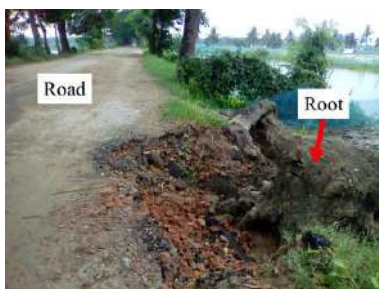
Figure 20 Uplifted tree damaged the road.

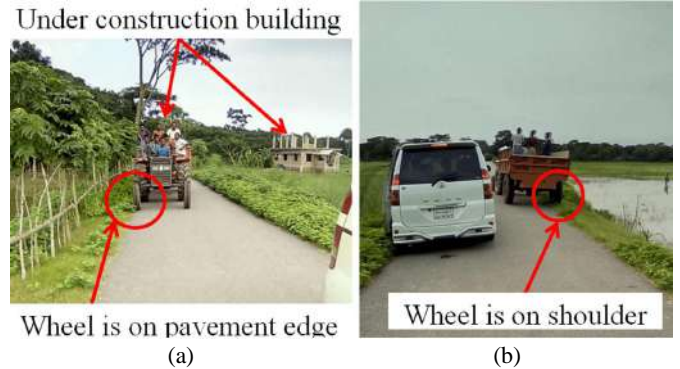
When a road network is developed in rural area, economic activity increases. Some people build multi-storied buildings beside road. So, loaded trucks enter into rural roads for which the road is not designed. During passing other vehicle, wheels of truck go on soft shoulder causing initiation of damage at pavement edge and shoulder (Figure 21). Because of frequent movement of loaded truck the small damage becomes bigger.

Figure 21 Truck is on (a) the edge of pavement and (b) shoulder.

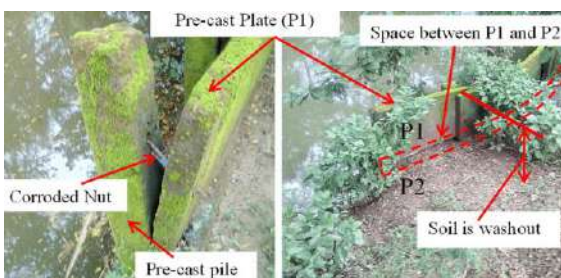
Palisading is done to stabilize the slope of the road along the pond, khal and river. In most of the cases palisading does not work properly. Figure 24 shows the design of palisading followed by LGED. Firstly the precast piles of 3 m length are driven into the existing soft soil at a c/c distance of 0.90 m. Thereafter the RCC precast plates are hooked using nuts and bolts. After one or two years of construction the nuts and bolts become corroded and slipped from hooked piles (see Figure 25(a)). Besides, in between two vertical RCC plates small gap exist through which the soil washed away day by day and erode the slope (Figure 25(b)). Later this design is modified by LGED. They used cast in place plates instead of precast plates. However, this system is not stable in many soil conditions of coastal districts. The posts are inserted within the soft soil layer. Failure of palisading is observed in Kajiarchor, Shariatpur (Figure 26). Existing typical design and construction methodology of palisading need to be revised. Palisading design need to be modified with proper stability analysis by Geotechnical Expert.

Figure 25 (a) Nut corroded and (b) Soil washed out in between the plates.

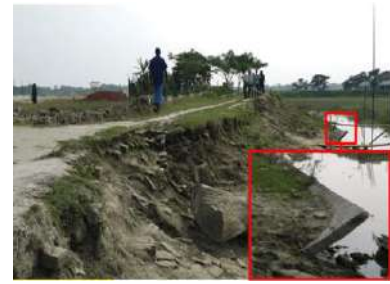
Figure 26 Palisading failed.

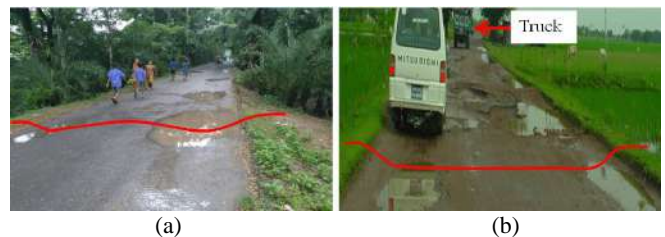
When roads are constructed, crown and 3% lateral slope is maintained (Road Design Standards of LGED, 2005). After one year of construction, rutting and subsidence of pavement create water logging on the road pavement. This water logging damages the bituminous carpeting and subsequently base layer. Two photographs of Khulna region are exhibited in Figure 27 (a) and (b). Figure 27 (a) is the photo of rural road constructed in 2015 and the water logging is started in 2016 though the pavement is not damaged yet whereas Figure 27 (b) represents the photograph of another road (more than one year) where due to water logging as well as vehicle movement the pavement and base were damaged.

Figure 27 Water logging on the new pavement road. (a) Initial settlement and (b) settlement and wide spread pot holes.

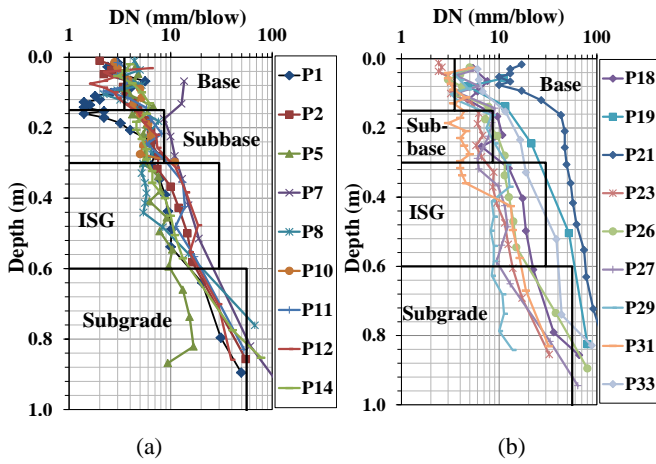
The recommended CBR value verses DCP penetration per blow for rural road construction was collected from LGED as shown in Figure 28. To compare the LGED recommended DCP values with field DCP values, total 34 DCP (Dynamic Cone Penetration) tests were conducted in rainy season on some village roads in Khulna district, Bangladesh. Test locations are listed in Table 1. Results of DCP tests done on road pavement are shown in Figure 29 (a) and (b) whereas results of DCP tests done on shoulders are shown in Figure 30 (a) and (b). In Figure 29 and Figure 30, the black lines are the LGED recommended maximum DCP penetration per blow (denoted as DN in mm/blow) for various layers of pavement. Where DN exceeded black line indicates not meeting the requirement set by LGED.

Figure 29 DCP test results conducted on the village road.

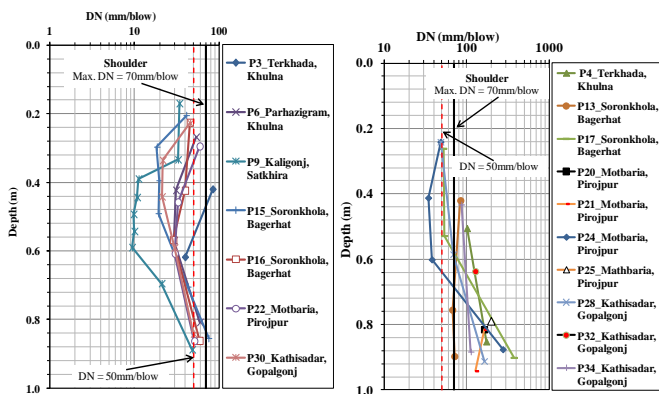
Figure 30 DCP tests conducted on the shoulder of the rural road.

Rutting on road pavement may be attributed to inadequate base layer. Initiation of damage at the edge of pavement may be attributed to inadequate shoulder. Shoulder and widened part of road acts as confinement to existing road. Soft shoulder is not capable of giving confinement to pavement layers. That is why authors think that shoulder should be hard type with herring bone brick under which there should be a sub-base layer. Dumping of mud at shoulder and side slope must be avoided to make sustainable rural road.

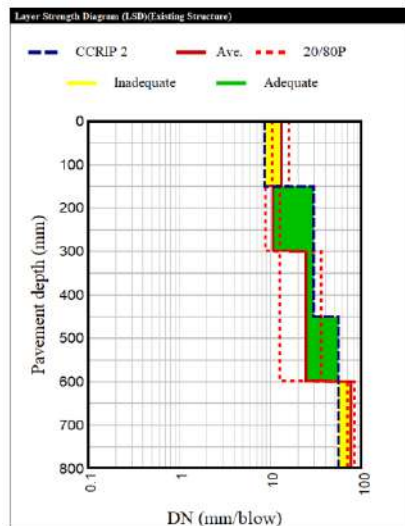
Figure 32 Analysed DCP test result (P7\_Modhupur, Khulna): Layer strength diagram.
