# Causes of Damage of Rural Road in Coastal Areas of Bangladesh

Md. Jahangir Alam<sup>1</sup>, Mohammed Emdadul Karim<sup>2</sup>, and Md. Shamsul Hoque<sup>1</sup>

**ABSTRACT:** Developing countries spend a lot of budget each year for elevating, widening or repairing the existing coastal rural roads. These rural roads are constructed for a design life of 10 years. But these low volume roads loose serviceability within two or three years. To find out the reasons of less sustainability, different rural road sites in coastal region were visited by the authors and sandy soil (used for Improved Subgrade) and clayey soil (borrow pit soil used for side slope and shoulder) were collected from 28 sites. Grain size analysis, liquid limit and plastic limit of collected samples were determined. Fineness Modulus (FM) of sandy soils ranged from 0.00 to 0.50 and the most borrow pit soils are lean clay. Dynamic Cone Penetration (DCP) tests were conducted on pavement and shoulder. The test results were analyzed and compared with the Local Government Engineering Department (LGED) recommended DCP values for rural road by employing the AfCAP LVR-DCP software. It is found that the DCP values of base

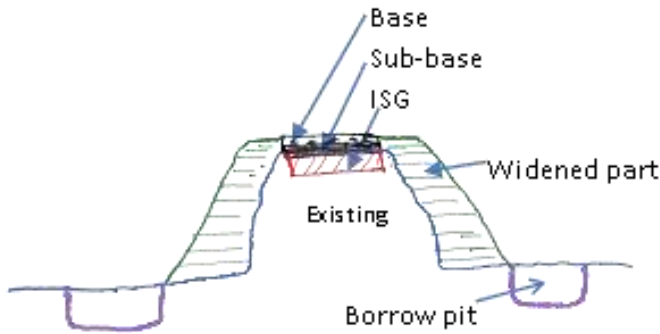
Figure 2 Typical rural road widening.

During site visits, authors observed that existing earthen roads are upgraded as shown in Figure 2. Earthen roads are widened using borrow pit soil from nearby land. 300 mm thick Improved Subgrade (ISG) is prepared using available local sand filling into box cut on top of the existing road. 150 mm thick sub-base is prepared using available local sand and brick chips mixed in 1:1 ratio. Then 150 mm thick base is prepared using brick chips only. 25 mm thick bituminous carpeting is done on base.

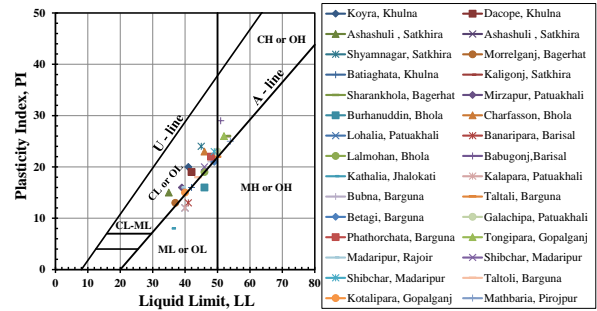
Figure 4 Position of borrow pit soil samples of coastal districts in the plasticity chart.

Among 28 borrow pit samples, 6 samples were silt, 6 samples were fat clay and 18 samples were lean clay (as per USCS) (Figure 4). These soils are used in widened part and shoulder of embankment without compaction. Widened part is not integrated with existing embankment by benching and layer by layer compaction. As a result, shoulder and widened part of embankment is soft where vehicle runs frequently during passing over.

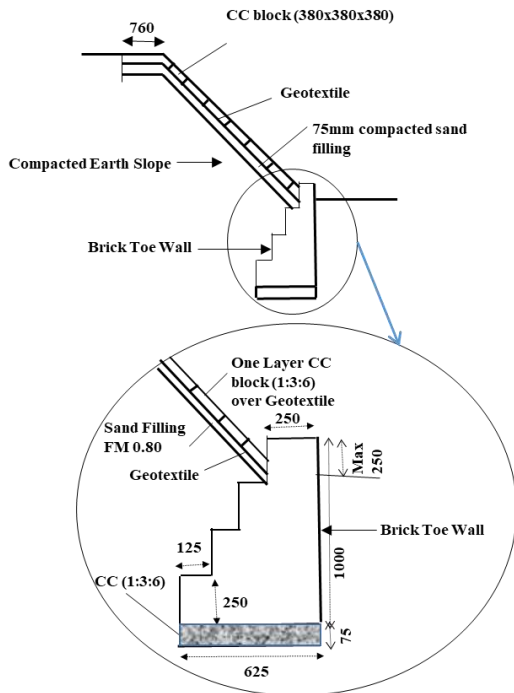
Figure 11 Schematic diagram of designed slope protection.

Some rural roads run along the bank of river or khal (Figure 10). This kind of road needs slope protection works for sustainable road construction. Sometimes, slope protection work is done using CC block revetment as shown in Figure 12. This is a typical design which is followed everywhere without any slope stability analysis. That is why sometimes slope failures are observed as shown in Figure 10(b) and Figure 12. Limited fund of rural road construction is a reason of not doing any proper slope protection design. If the slope protection is designed properly, construction cost of project will be more than the estimated budget.

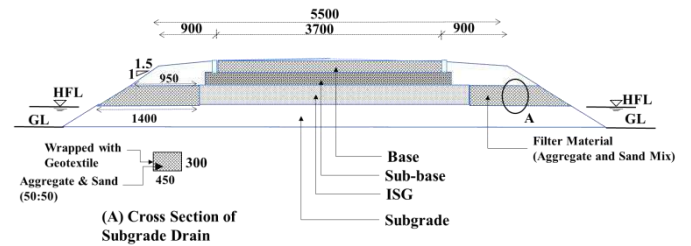
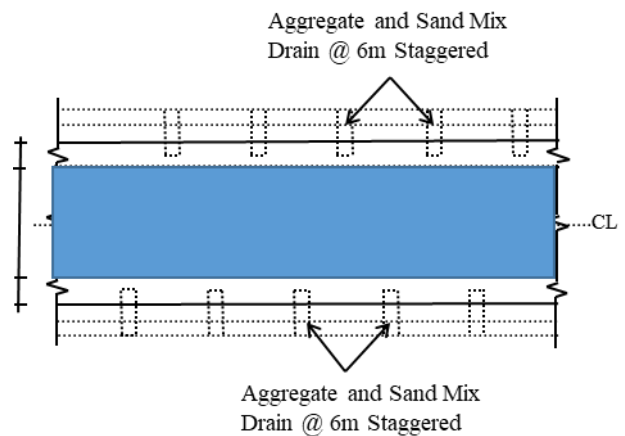
Figure 15 Modified design of road; (a) typical cross section of road with subgrade drain and (b) plan of subgrade drain.

Authors observed a subsurface drainage path is installed in some recently completed rural roads. In the both sides of subgrade layer aggregate and sand wrapped with geo-textile are installed. The cross section of this modified road is shown in Figure 15 (a). This wrapped aggregate and sand mixture would work as a drain line through subgrade of the road. Here, the water inlet and outlet are placed in a zigzag pattern that is illustrated in Figure 15(b). Subgrade drain is 450 mm wide and 300 mm thick (Figure 15(a)). The center to center distance of subgrade drain is 6 m. However, in the rainy season it was found that the soils above the subgrade drains were washed away (the dashed oval marked portions in Figure 16). In Figure 16 (a) two photographs are exhibited where this type of erosion observed.

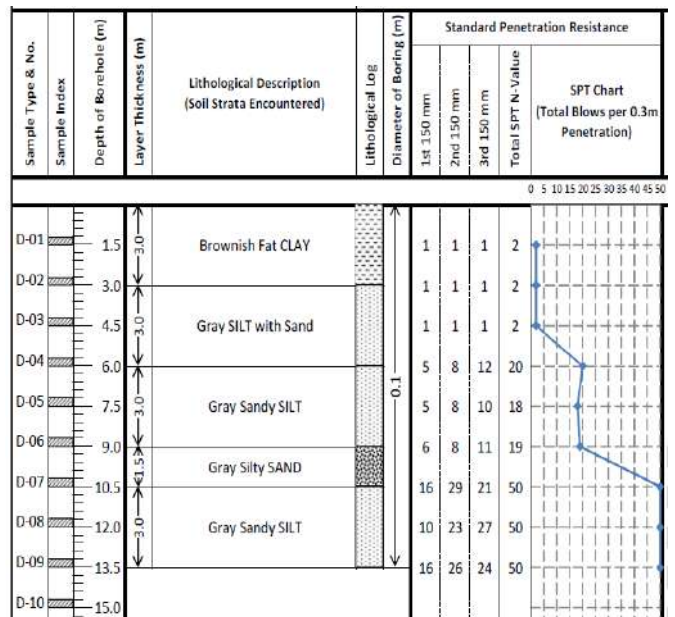
Figure 22 A subsoil bore log at Civil Surgeon Office, Gopalganj, Dhaka

Nearly 85 percent of Bangladesh is underlain by deltaic and alluvial deposits of Ganges, Brahmaputra, and Meghna river systems (Alam et al, 1990). In the previous studies of the coastal region of Bangladesh, it was found that the sub-surface soil is soft (Kabir et al, 2000; Nath et al, 2017). At least 4-8 m soft clay exists at top layer of subsoil in coastal districts. Figure 22 shows a bore log of plot for Civil Surgeon office, Gopalganj. In another research report on “Ground Improvement on Khulna Soft Soil” revealed that more than 15 m soft clay layer exist at top of subsoil in Khulna region (AsCAP final report, 2017). The soft soils consist of silt or clay. Besides, in that region, in some places, an organic clay layer of 3-5m thickness was found. This organic layer was formed from the decomposition of mangrove vegetation of the largest mangrove forest of Bangladesh (Kabir et al, 2000). As the soils of the coastal area are soft and sometimes those are organic, settlement of the newly constructed road or widened or elevated road continues more than 10 years. This settlement is not uniform along longitudinal direction of road.

When roads are constructed on this subsoil, consolidation and squeeze out of soft clay cause subsidence, cracking and rutting of constructed road. Subsoil investigation should be mandatory for road project in coastal areas. Special attention should be given in the planning and design phase of road projects. Geotechnical Engineers should be involved in the design phase. Figure 23 shows the settlement of road on soft soil. In the both sides of the road fish farm is full of water.

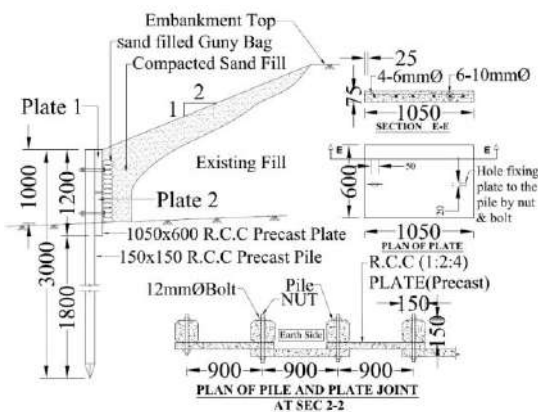
Figure 24 A typical design of palisading implemented by LGED.

Palisading is done to stabilize the slope of the road along the pond, khal and river. In most of the cases palisading does not work properly. Figure 24 shows the design of palisading followed by LGED. Firstly the precast piles of 3 m length are driven into the existing soft soil at a c/c distance of 0.90 m. Thereafter the RCC precast plates are hooked using nuts and bolts. After one or two years of construction the nuts and bolts become corroded and slipped from hooked piles (see Figure 25(a)). Besides, in between two vertical RCC plates small gap exist through which the soil washed away day by day and erode the slope (Figure 25(b)). Later this design is modified by LGED. They used cast in place plates instead of precast plates. However, this system is not stable in many soil conditions of coastal districts. The posts are inserted within the soft soil layer. Failure of palisading is observed in Kajiarchor, Shariatpur (Figure 26). Existing typical design and construction methodology of palisading need to be revised. Palisading design need to be modified with proper stability analysis by Geotechnical Expert.

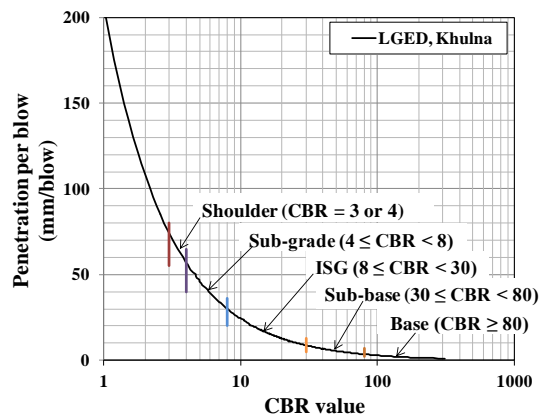
Figure 28 CBR verses DCP penetration rate (mm/blow) recommended by LGED for rural road.

The recommended CBR value verses DCP penetration per blow for rural road construction was collected from LGED as shown in Figure 28. To compare the LGED recommended DCP values with field DCP values, total 34 DCP (Dynamic Cone Penetration) tests were conducted in rainy season on some village roads in Khulna district, Bangladesh. Test locations are listed in Table 1. Results of DCP tests done on road pavement are shown in Figure 29 (a) and (b) whereas results of DCP tests done on shoulders are shown in Figure 30 (a) and (b). In Figure 29 and Figure 30, the black lines are the LGED recommended maximum DCP penetration per blow (denoted as DN in mm/blow) for various layers of pavement. Where DN exceeded black line indicates not meeting the requirement set by LGED.
